# Manhole Inspection Summary

Manhole # S43KK\_029MH

Insp Date: **8/13/08 11:20 AM**

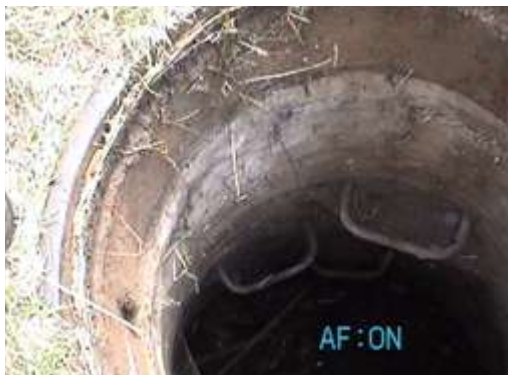
Defect 2

Infiltration: ☐ None ☐ Joint ☐ Cracks ☒ **Mortar** ☐ Roots ☐ Wall

Infiltration

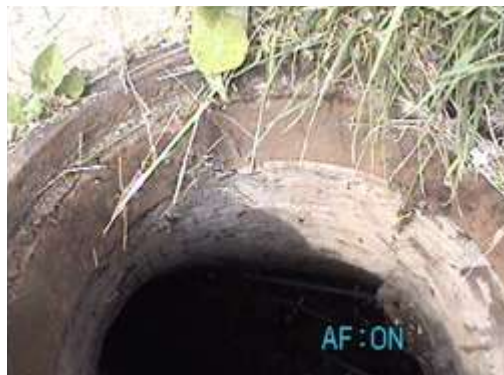
Defect 1

**Frame** Offset: **0.5** (in.) Condition: ☐ Sound ☐ Cracked ☒ **Leaks**

Frame leaks

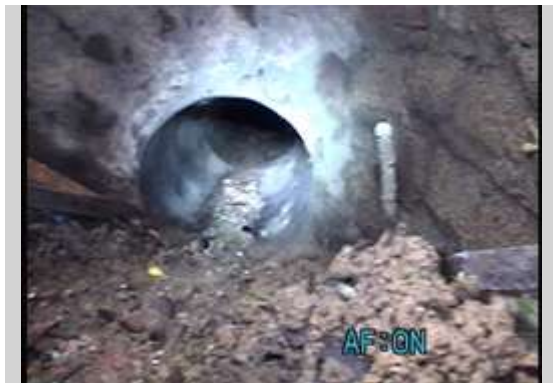
12 O'Clock Outflow

8 in. Circular Gravity Sewer  
Pipe Out @ 12 O'Clock

Infiltration: **None** Pipe Seal Cond: **Sound**
